20-251E

Re: **World Trade Center**
New York, New York

One World Trade Center

Subgrade (Parking & Storage Areas)

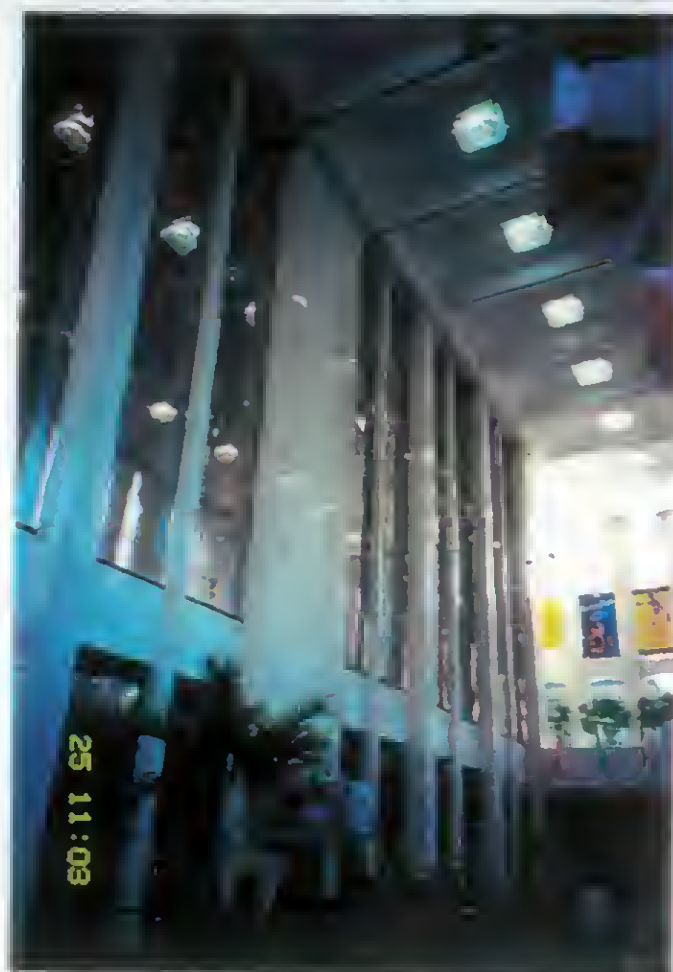
Photograph 8

Lobby and elevator
banks

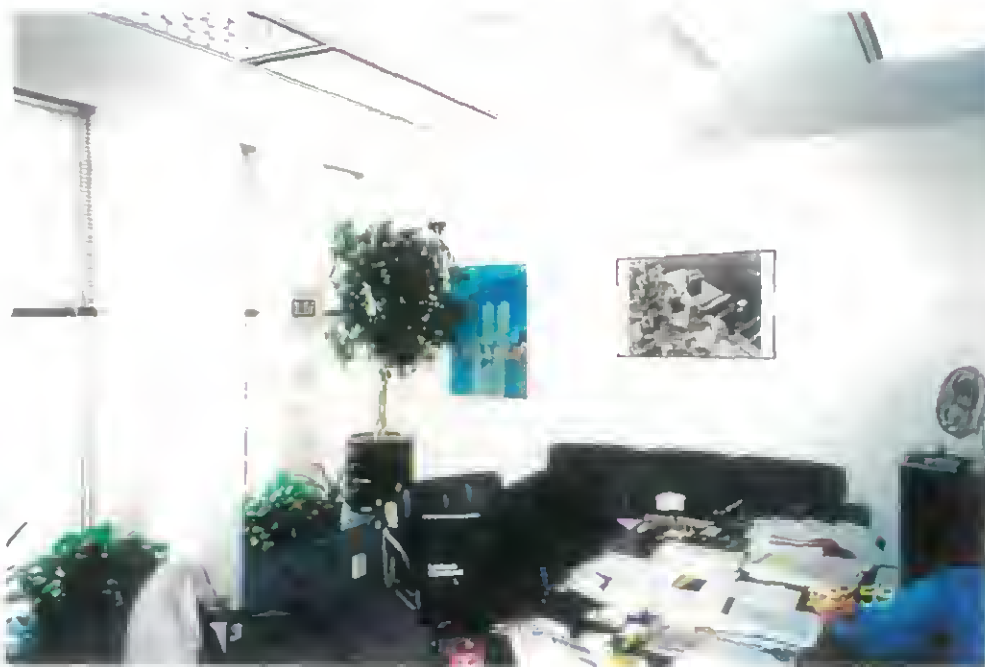
Photograph 14

Typical office

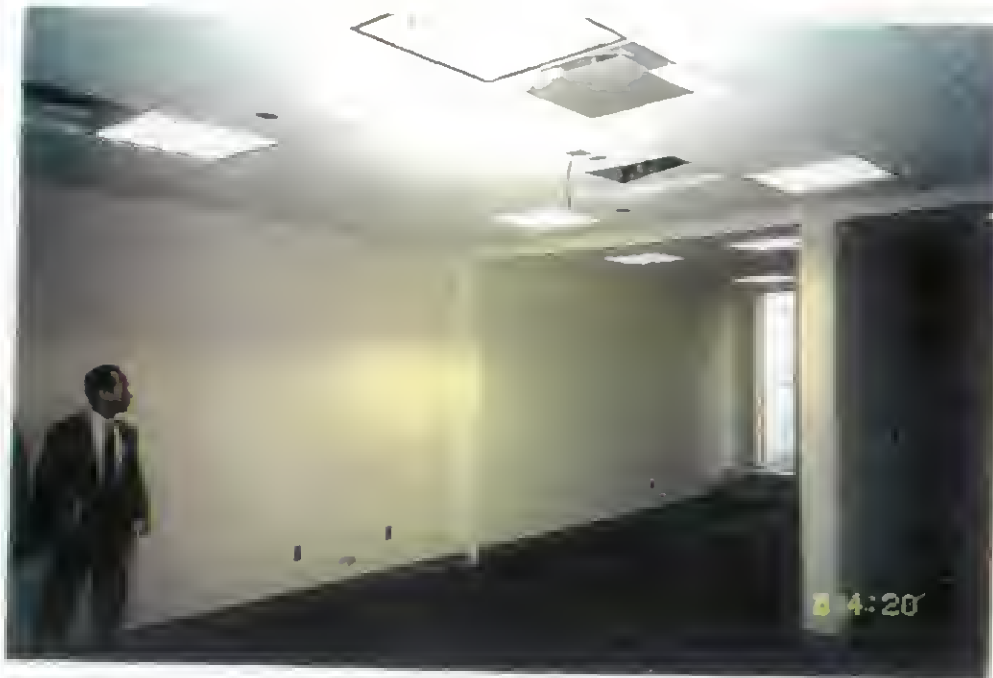
Photograph 15

Vacant space

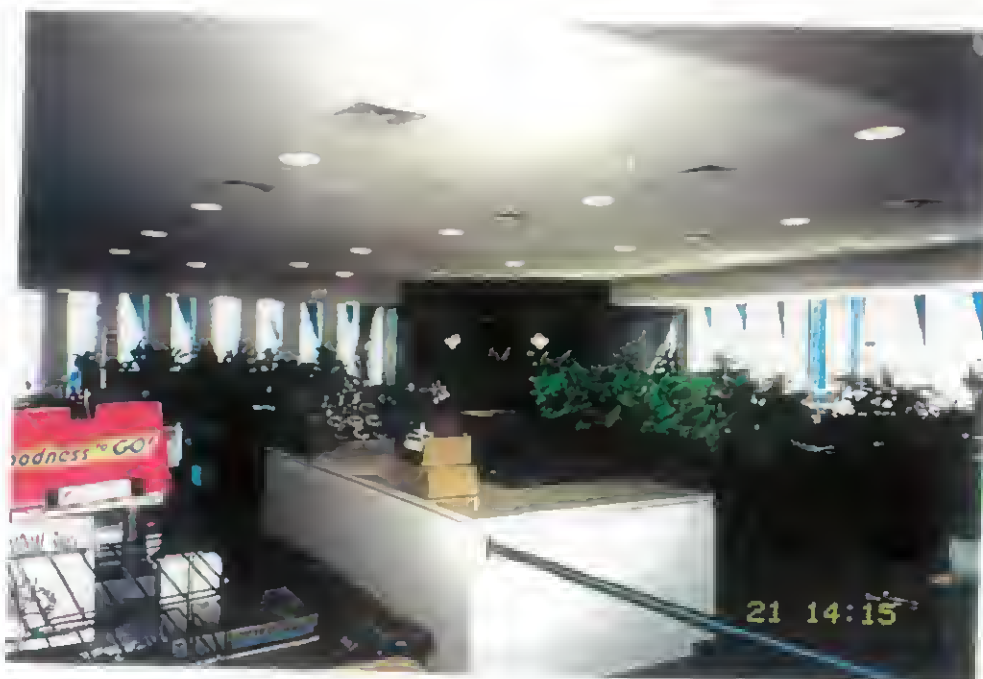
Photograph 17

Port Authority
Cafeteria on 43rd
floor

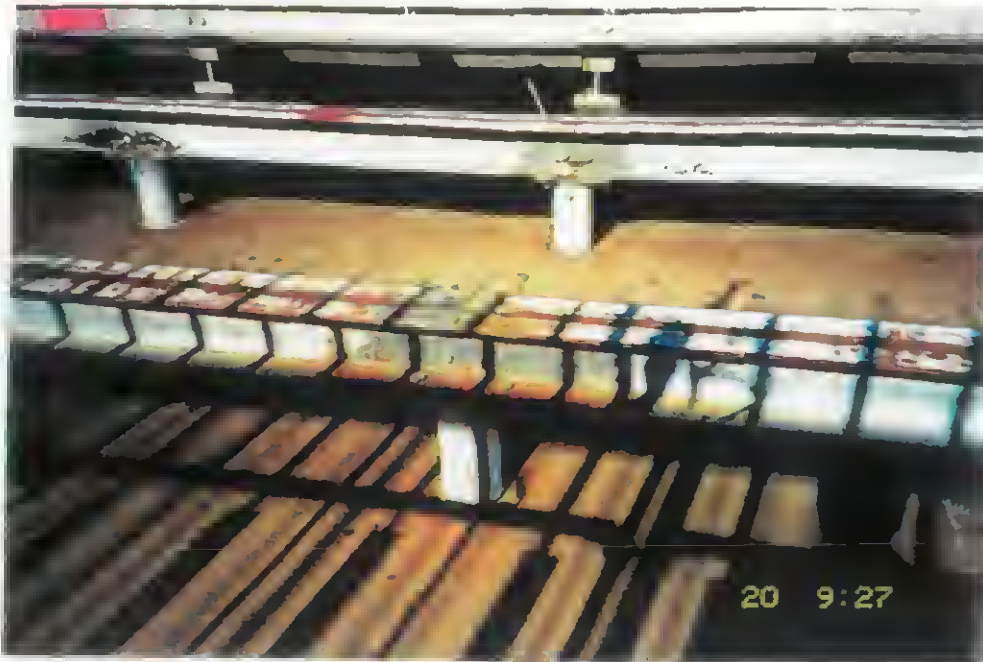
Photograph 7

Rusted window
washing rig rails

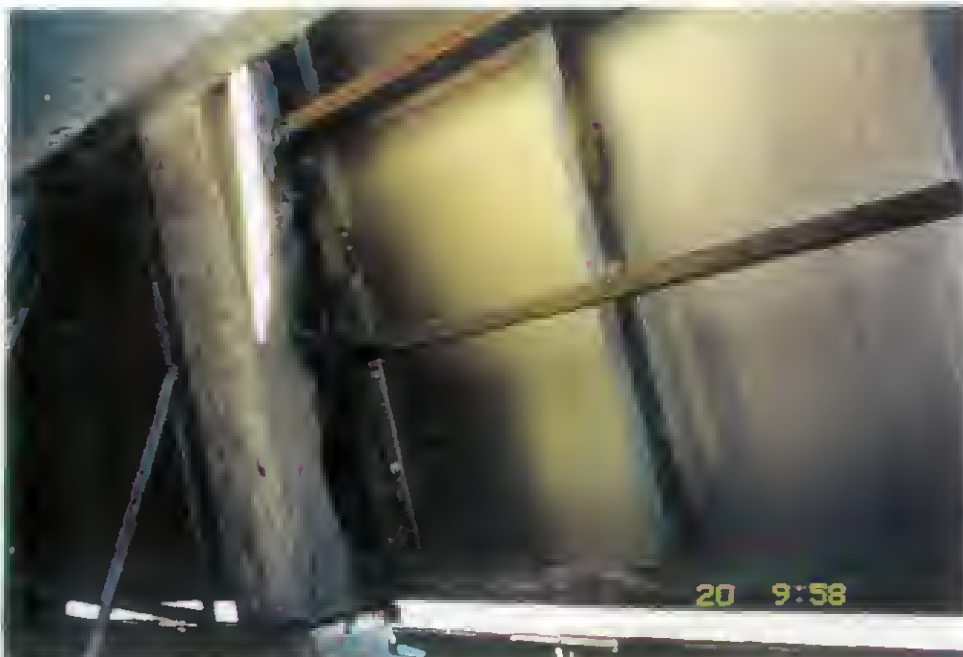
Photograph 8

Rusting purlins for
exposed facade at
110-story and at
roof

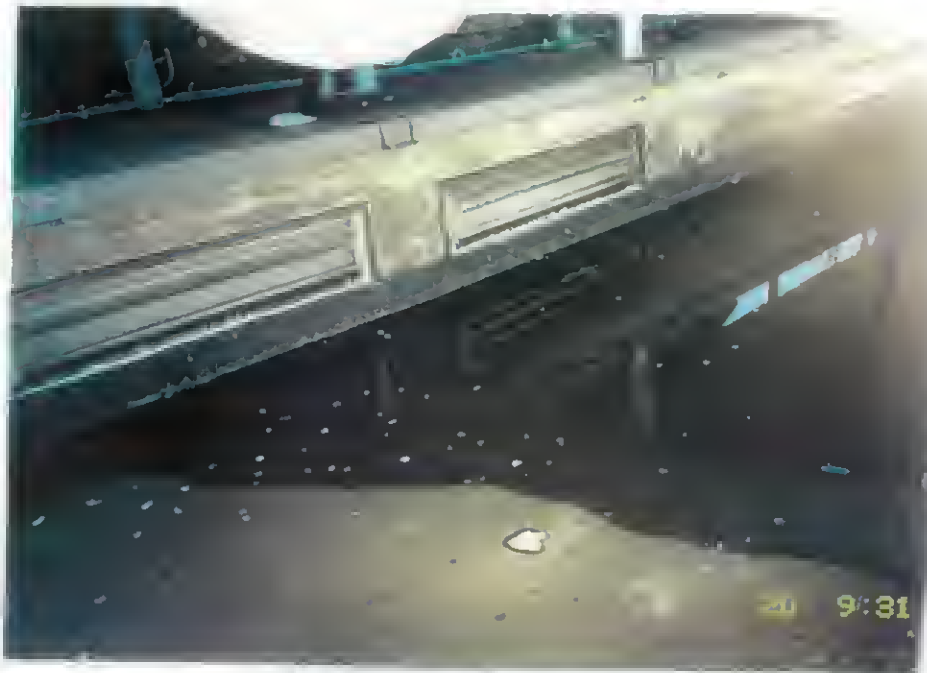
Photograph 9

Puddles at main roof
indicate poor
drainage

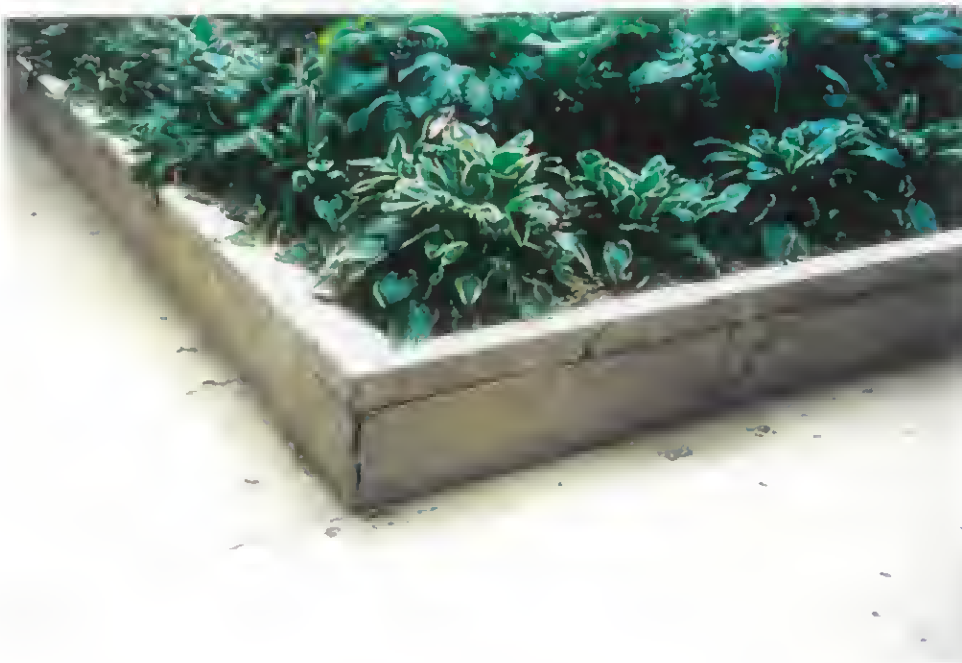
Photograph 16

**Planter damage
at Plaza level
near 4 WTC**

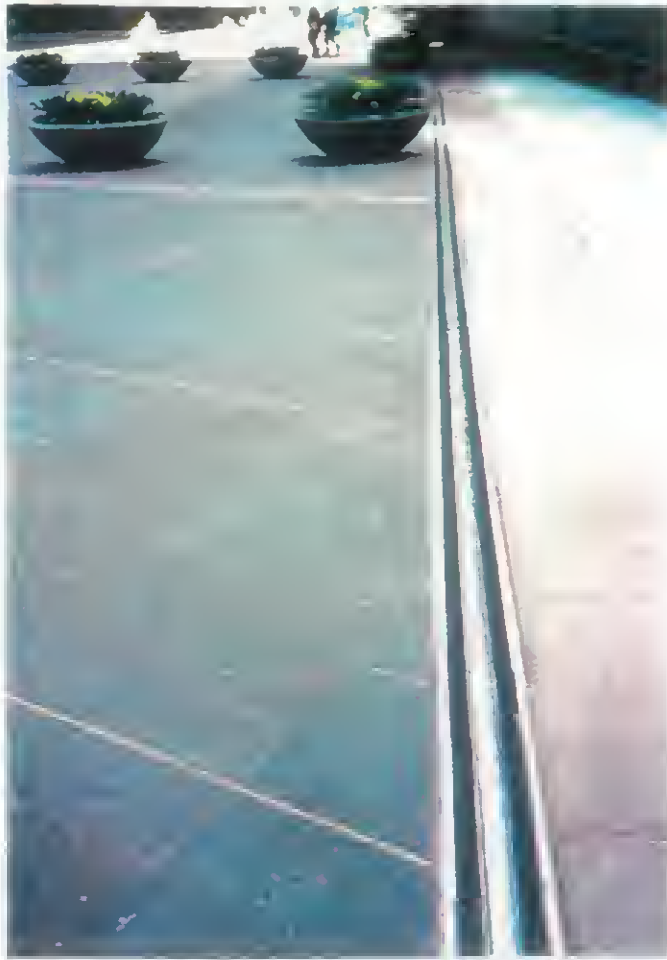
Photograph 17

Expansion joint
in Plaza deck
along east side
near Church
Street

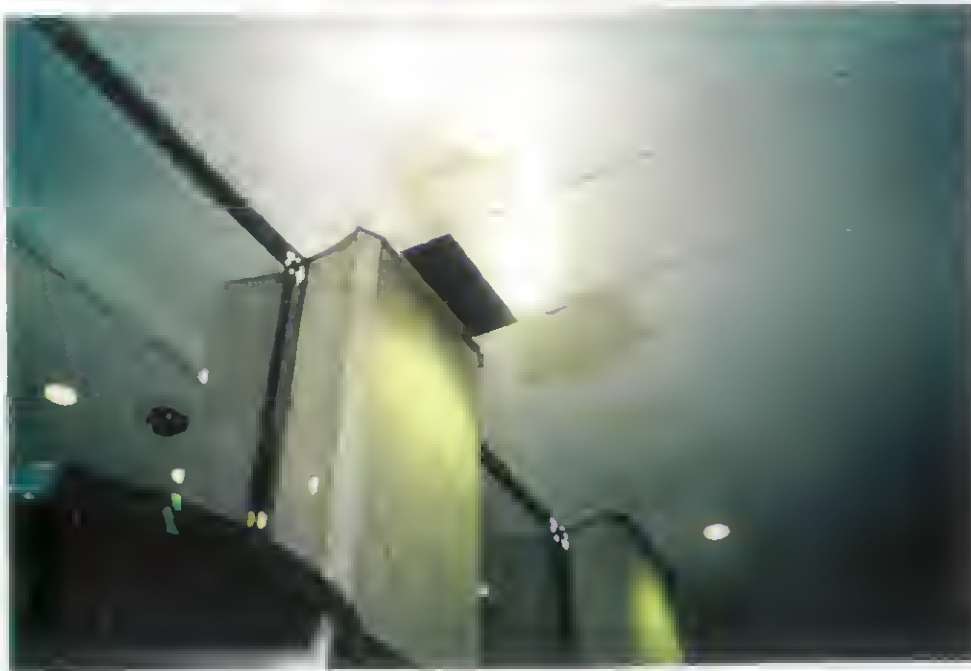
Photograph 18

Leaks at
underside of
Plaza deck
visible near 1
WTC entrance

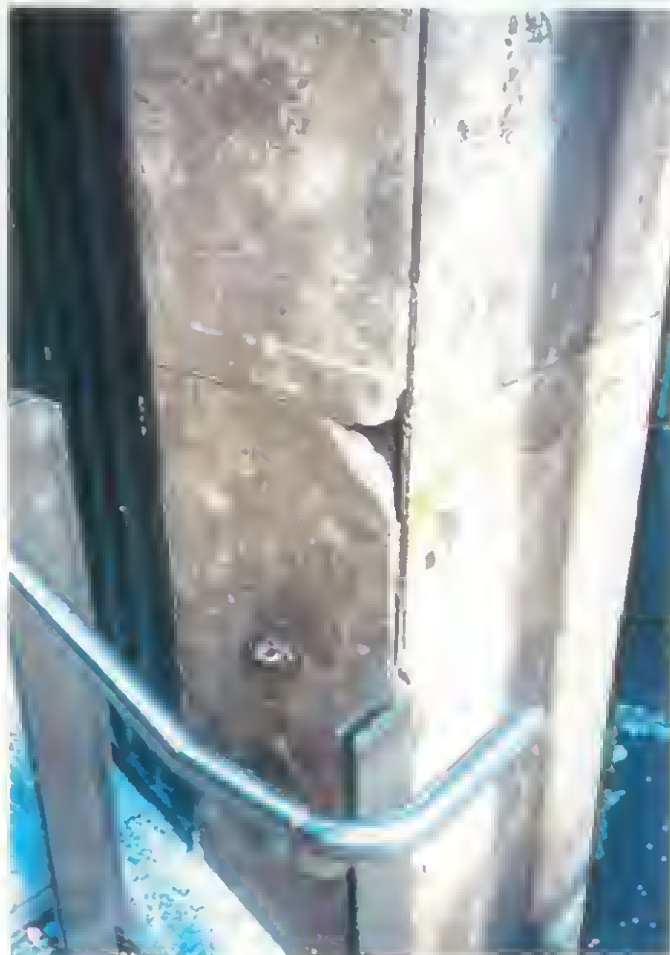
Photograph 28

Damaged marble
panel near
bottom of
exterior stairway
between 1 and 4
WTC

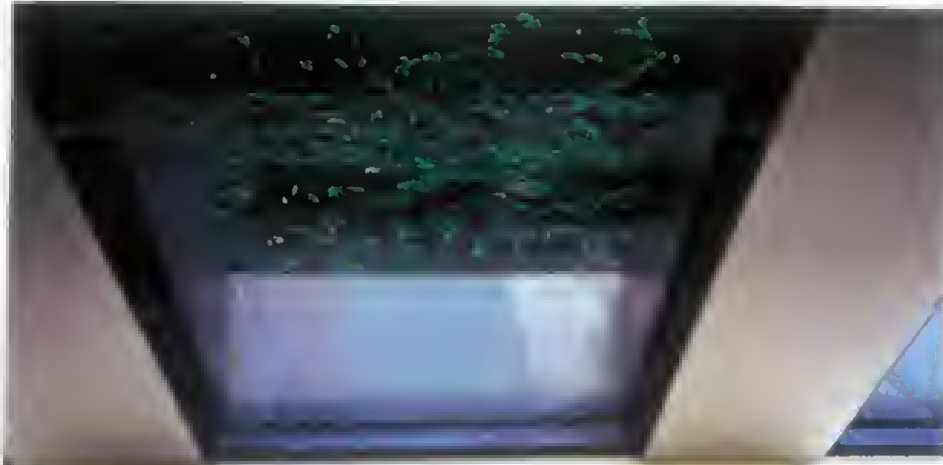
Photograph 13

Detail of sill
condition at 4th
floor where
painted finish is
failing

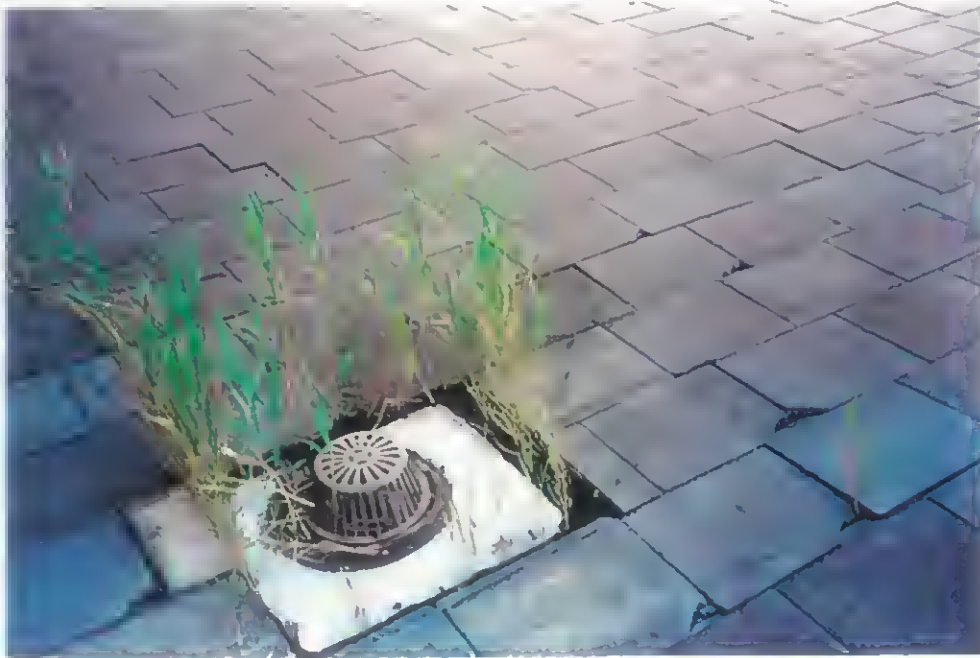
Photograph 13

Detail of roof
drain with
vegetation
growth
supported by the
moisture held in
paver backing

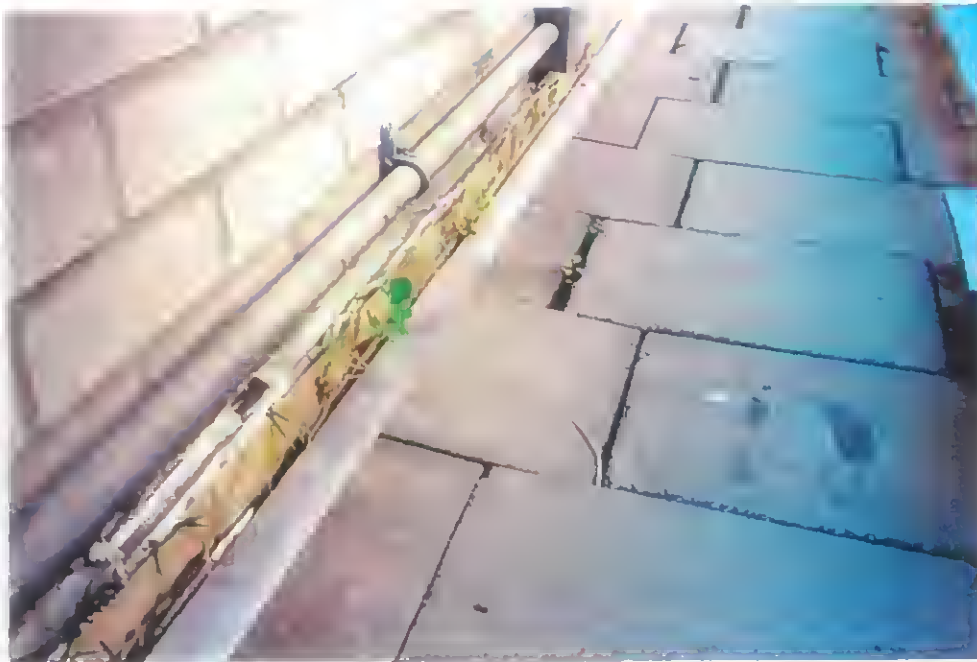
Photograph 14

Detail of
perimeter
flashing detail
with vegetation
growth

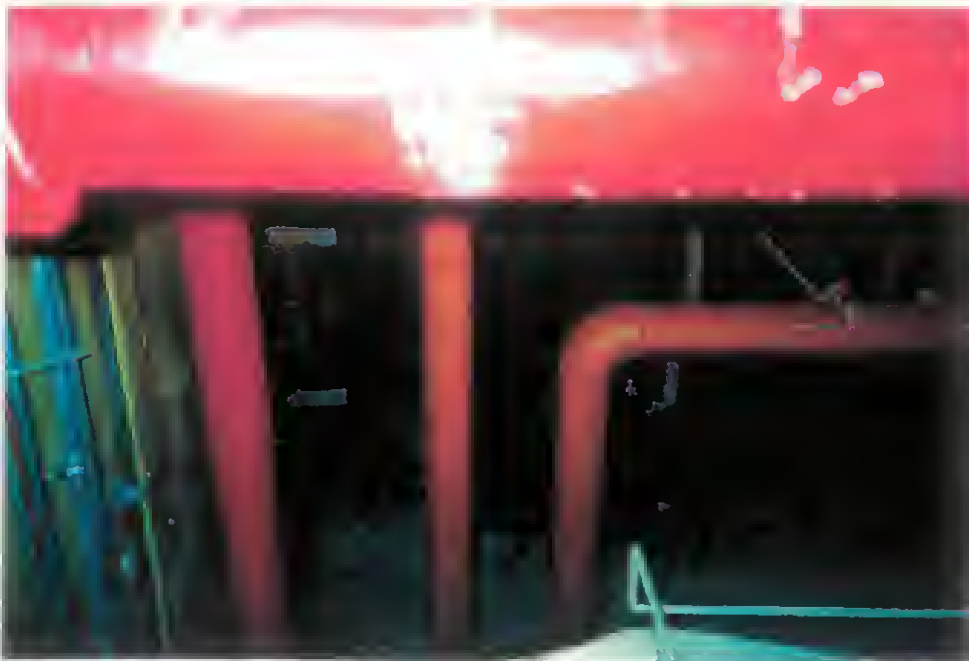
Photograph 16

**Severely rusted
underside of roof
deck from
previous roof
leaks**

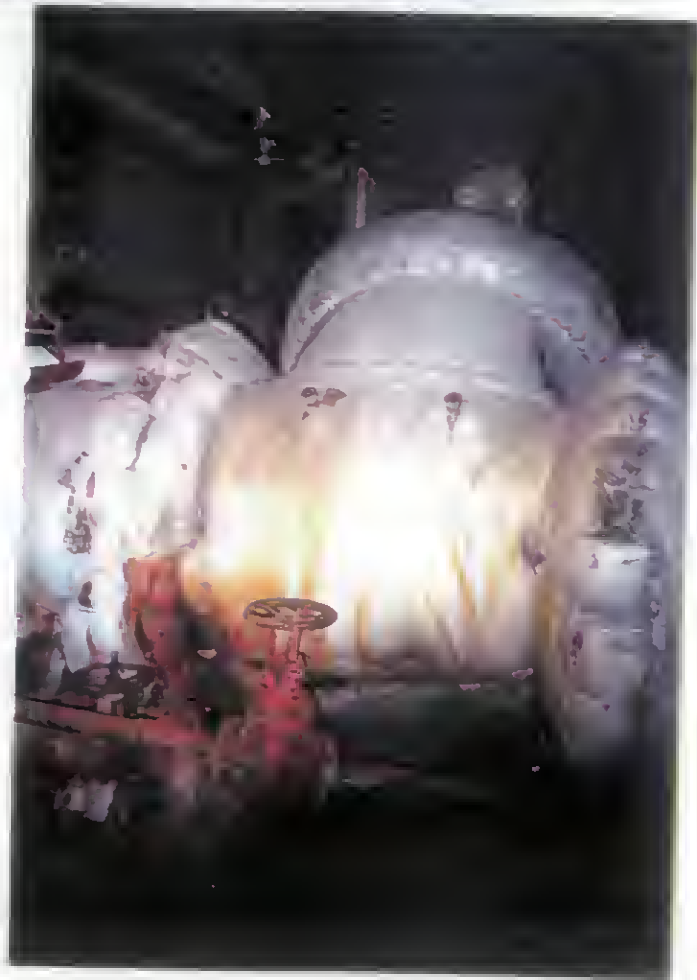
Photograph 14

Steam service
valve (planned
for replacement)

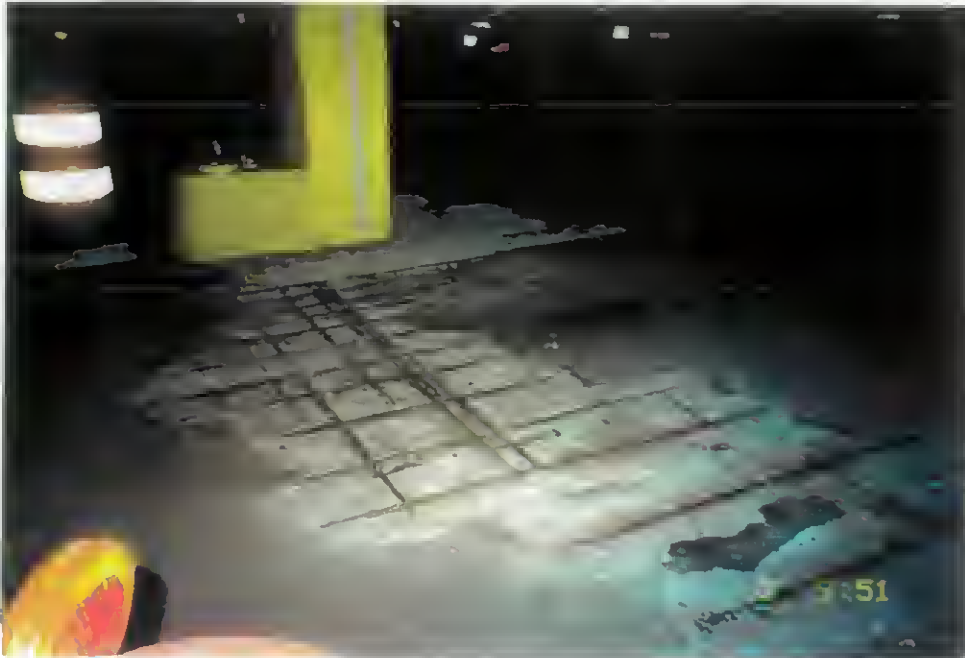
Photograph 7

Spalling garage
slab - Level 2, North

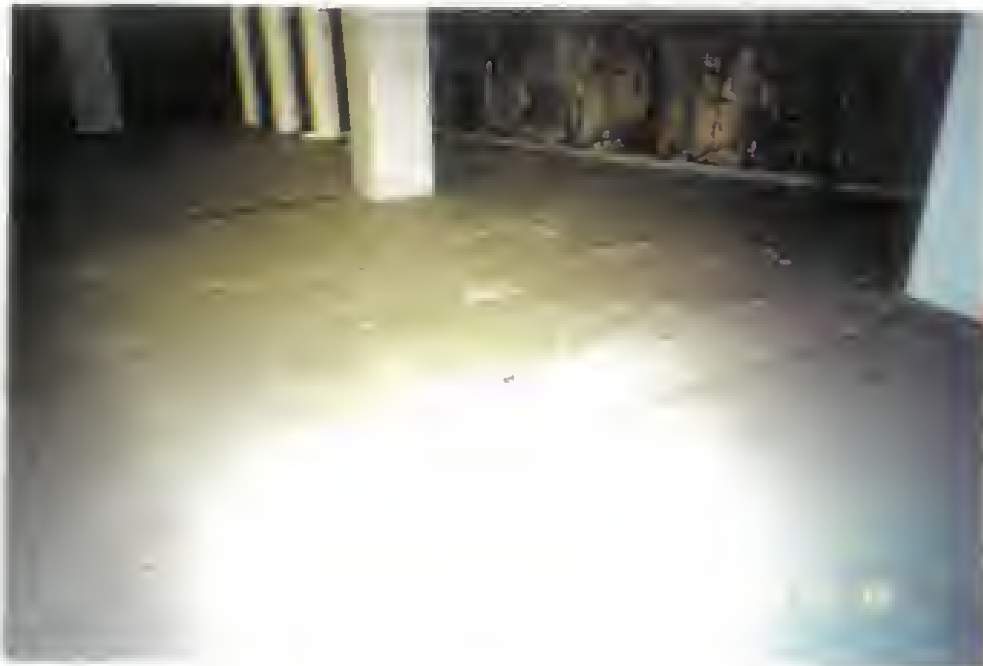
Photograph 8

Spalling slab in B5
Central Plant

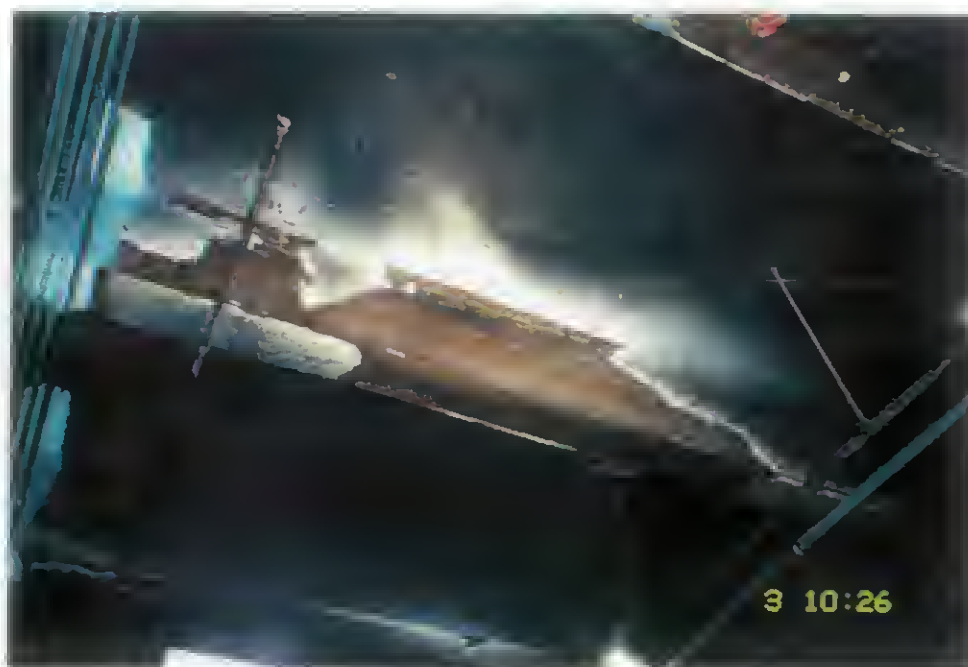
Photograph 12

Missing fireproofing
at loading dock

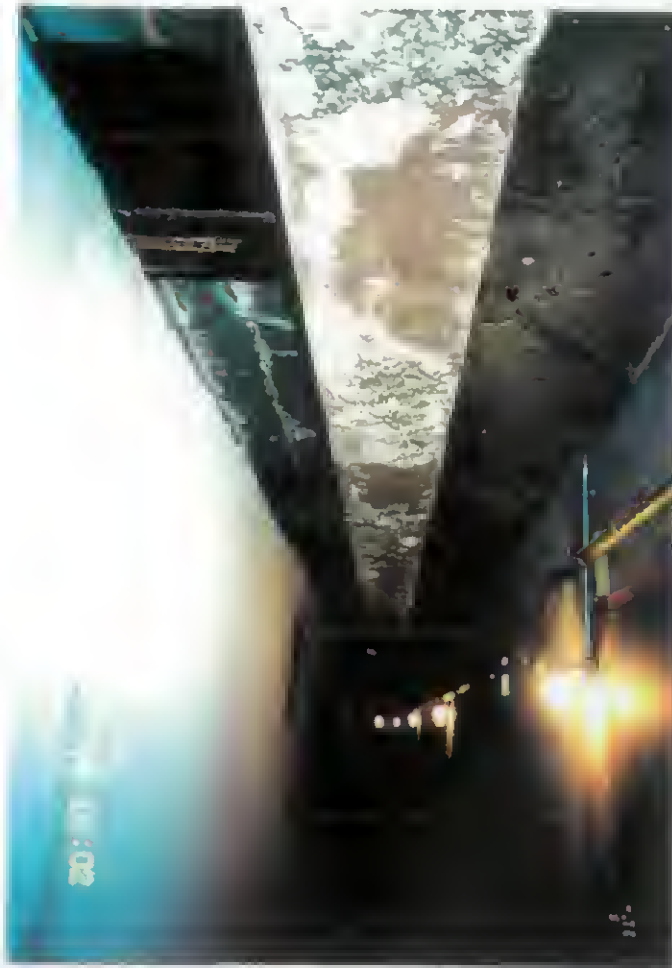
Photograph 13

Missing fireproofing
at ventilation
plenum - B2 North

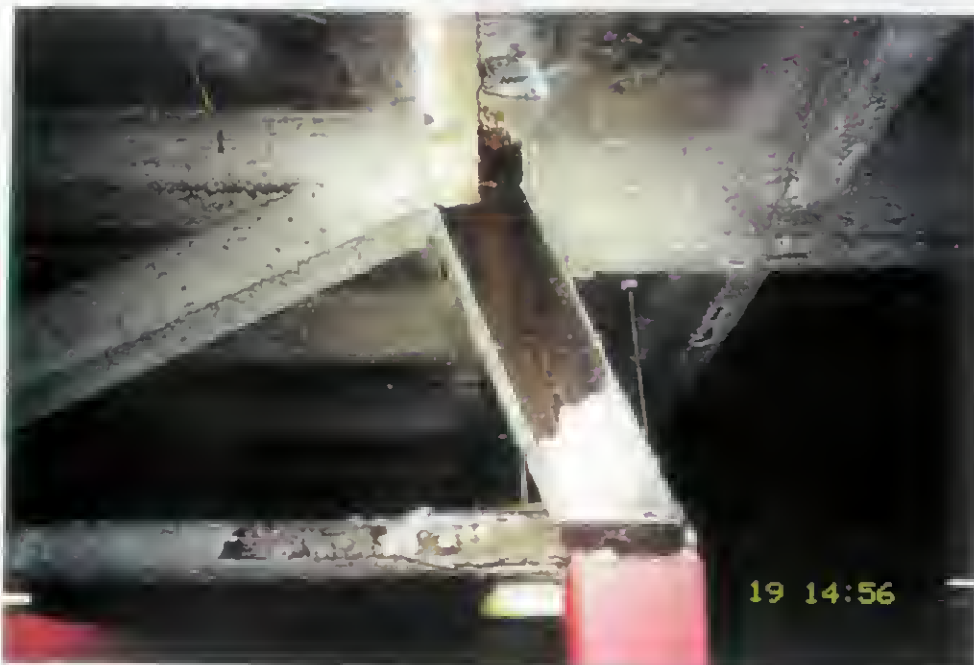
Photograph 14

Missing fireproofing
at B-2 Garage

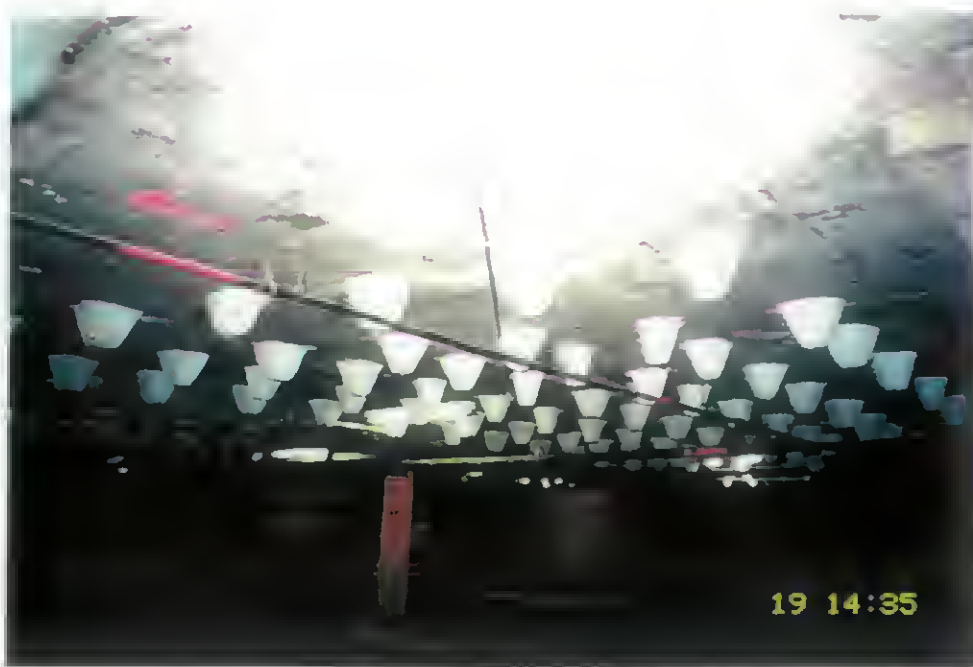
Photograph 16

Repairs of ceiling
slab at B2 ceiling
due to bomb
explosion

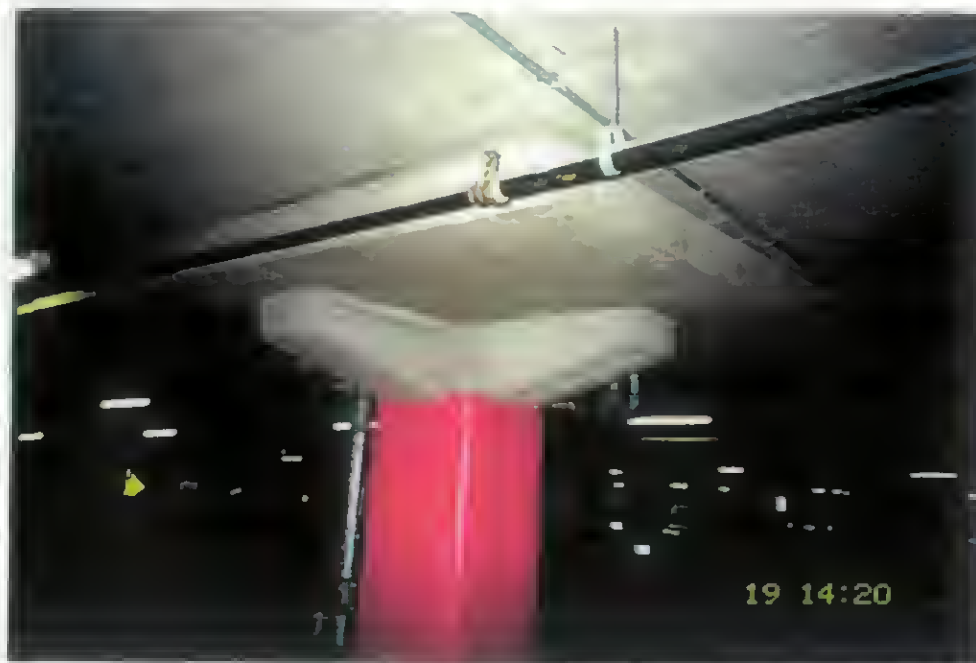
Photograph 17

Repairs at column
brackets to support
weakened slabs

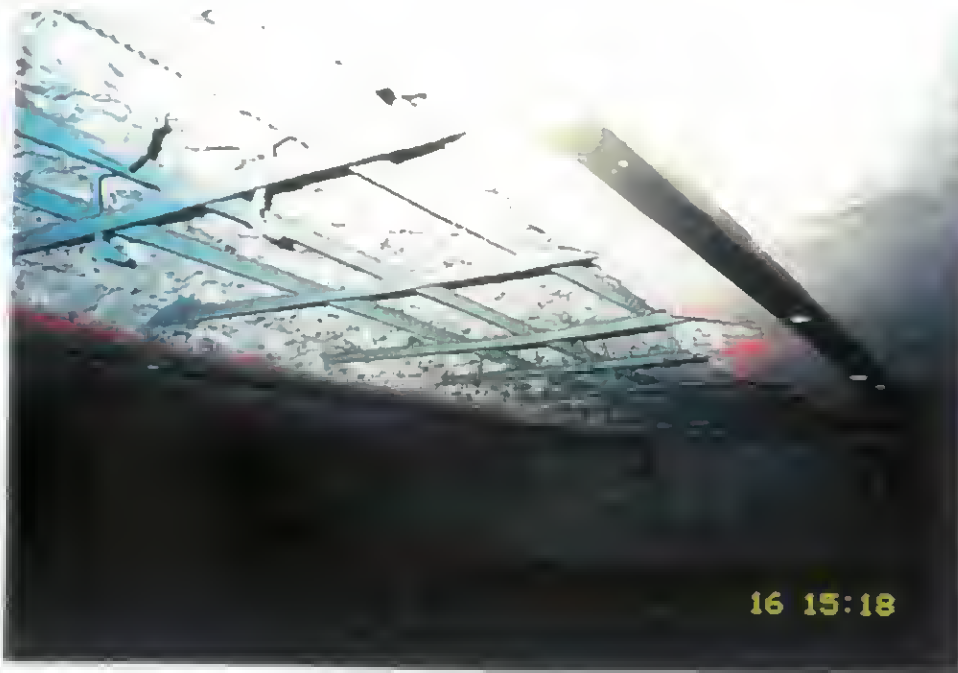
Photograph 19

Ceiling under B4
ramp (south) in
ventilation plenum
requires repairs

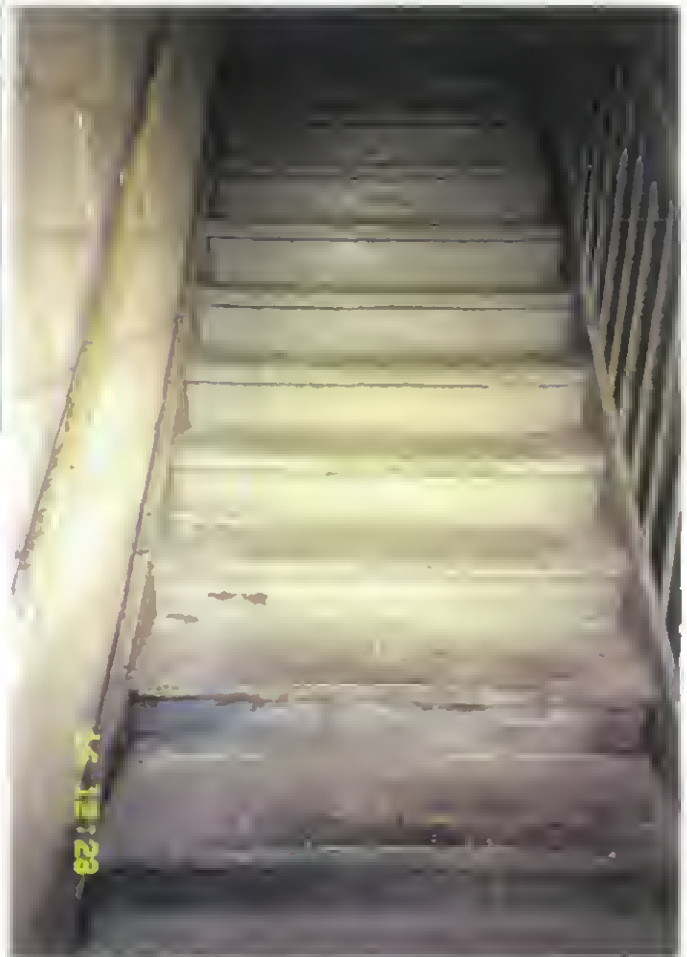
Photograph 22

Typical subgrade
stair requires
cleaning and
some require
painting
